SUBJECT: Site Inspection, Duchesne County Cedar Buttes Mine and Robert Fausett Cedar Buttes #1 Mine, M/047/028 and S/047/067, Uintah County, Utah

Date of Inspection: August 14, 2003

M/047/028 and S/047/067, Cedar Buttes Mine, Duchesne County and Robert Fausett

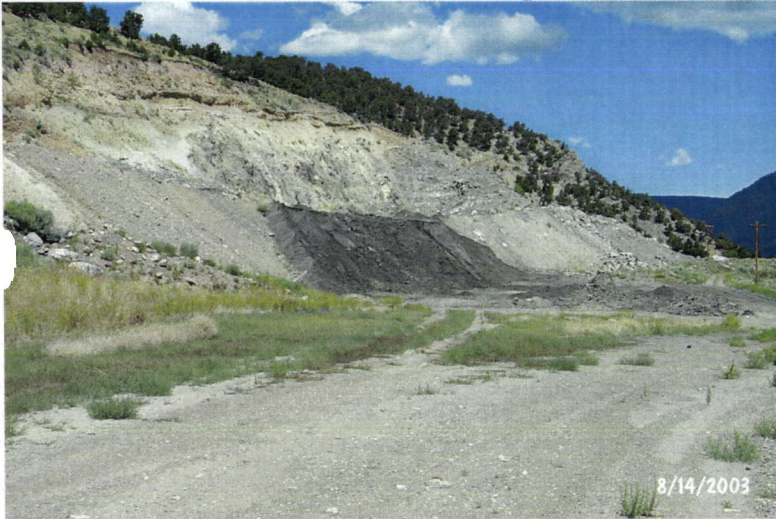
Photos 1 through 3 show the highwall and pit in the Duchesne county area. Material that might be used to backfill the highwall is mostly to the east and south of the highwall and pit although immediately east of the pit is a rock outcrop (right side of Photo 3). To the south of the pit, the material looks as if it might serve as an acceptable substitute topsoil.

Photo 1. Overview of the highwall at the Duchesne county site.

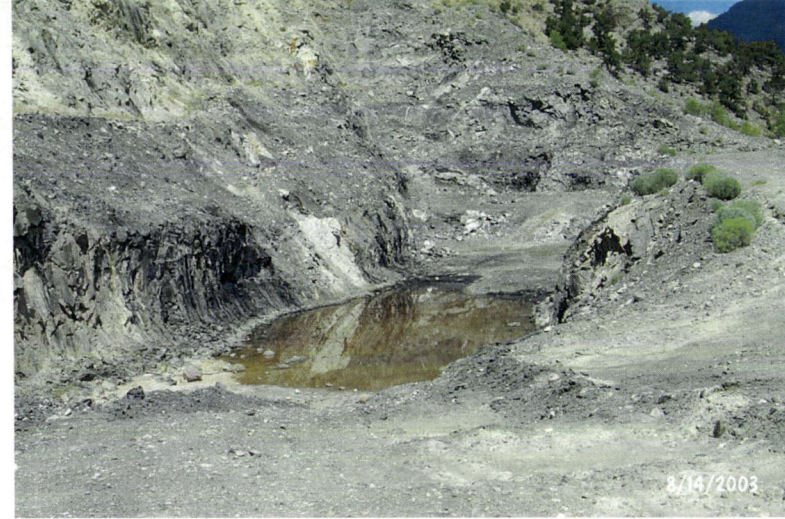
Photo 3. Pit at the base of the highwall.

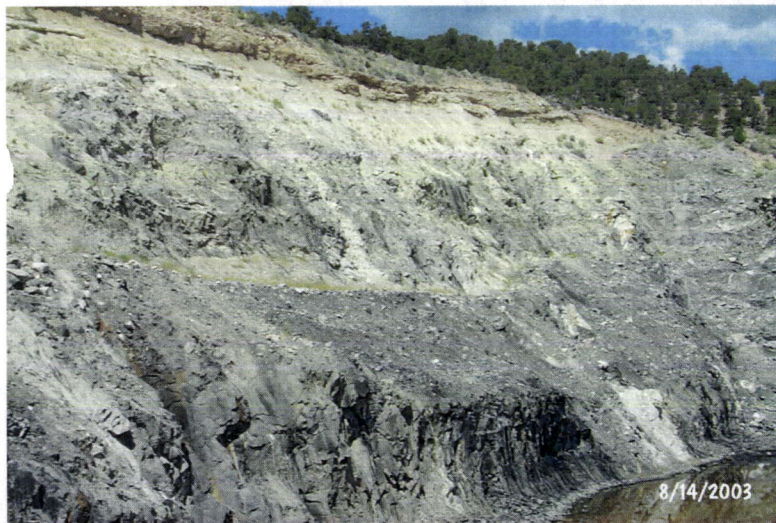
Photo 2. Closer view of the highwall.

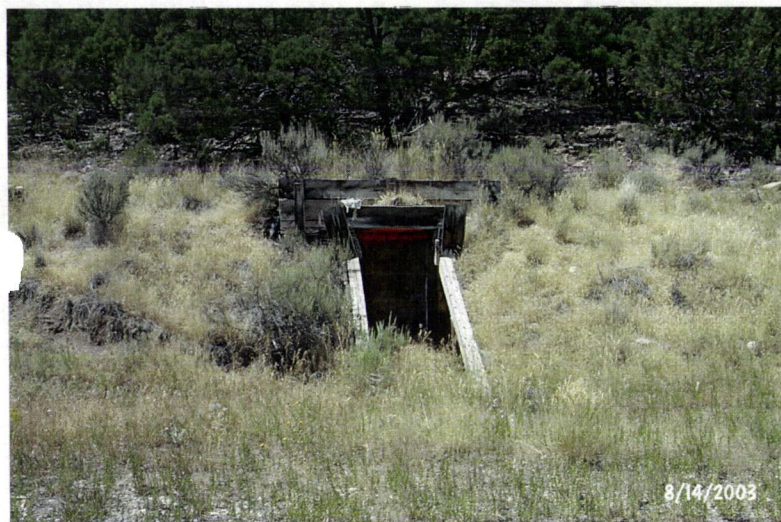
Also in Mr. Fausett's area was an underground storage area with an unlocked door. Inside were two empty dynamite boxes.

Photo 5. Underground storage area in the area permitted by Robert Fausett.

If either of the operators intends to store explosives on site, they must be kept in a properly secured, locked, grounded container. Explosives must only be stored and used with established protocols from the Mine Safety and Health Administration and the Bureau of Alcohol, Tobacco and Firearms.
